MARINE INVESTIGATION REPORT M00W0265

ACCIDENTAL RELEASE OF LIFEBOAT

BULK CARRIER *PACMONARCH* ENGLISH BAY,VANCOUVER, BRITISH COLUMBIA 26 OCTOBER 2000

Report Number M00W0265

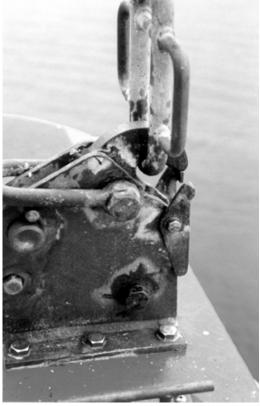
Photograph 9. View of hook, suspension ring, and retaining latch

The retaining latch is designed to pivot such that it can only open into the hook (see Figure 6). This design feature allows the suspension ring to be inserted into the hook assembly and prevents the ring from inadvertently slipping out. The retaining latch is not designed to carry any significant amount of weight.

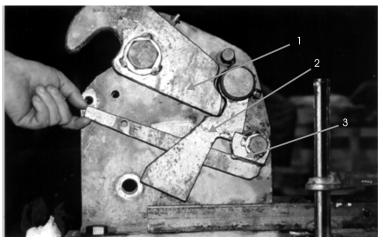
Photograph 10. View of hook in load-bearing (reset) condition 1. Hook, 2. Blocking lever, 3. Reset lever

In the load-bearing or reset condition of the hook assembly (see Photograph 10), the flat end of the hook bears against and transmits a load onto the blocking lever, which in turn rests against a cam profile on the

reset lever. At its contact surface with the hook, the blocking lever has a relief angle of 18°.

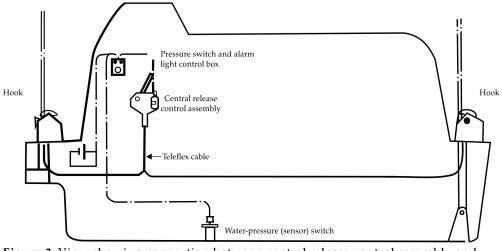
Figure 3. View showing connection between central release control assembly and hooks

At its free end, the reset lever carries a clevis joint to which is attached a teleflex cable. The other end of this cable is similarly fixed to a cable connection arm which, in turn, is fitted inside the central release control assembly (see Figure 3).

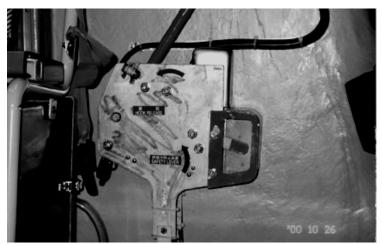
Photograph 12. Central release control assembly

The central release control assembly is just behind and to port of the coxswain's seat (see Photograph 12). It is made of two galvanized steel side plates to which are connected the release lever, the cable connection arms, and the interlock lever. A solenoid coil is mounted on top of the framework formed by the side plates.

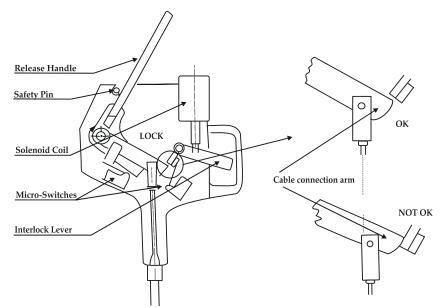
Figure 4. Internal schematic of central release control assembly

The lamps' indications are dictated by the contacts made between the cable connection arms, the interlock lever, and their respective microswitches. The positioning of these microswitches (see Figure 4), and the excessive play found in their sensing arms, allowed the panel lamps to falsely indicate the position of the interlock lever. When one or both of the cable connection arms were not being blocked by the interlock lever, the panel lights could incorrectly indicate that they were blocked.

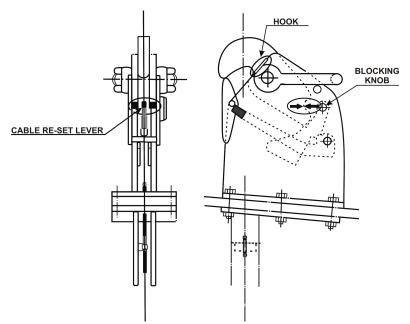
Figure 5. Arrangement of reference marks on hook assembly

On each hook assembly, the hook, the blocking lever, and the reset lever carry reference marks. The cheek plates have corresponding reference marks. The hook has been correctly reset when these marks are properly aligned.

The TSB's post-occurrence inspection of the hook assemblies indicated that, in the reset position, the reference marks on the reset levers were not aligned with the reference marks on the cheek plates. The top surface of the mark on the reset lever was just below the bottom surface of the marks on the cheek plates (see Photograph 20).

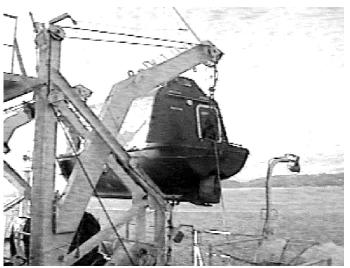
Photograph 19. Still from video showing gripe wrapped around after bollard

The lifeboat's outward motion creates tension in the gripes, which in turn creates angular velocity in the free end of the gripe. The free end of the gripe falls, causing the gripe to loop around the

bollard on the lifeboat and, as the relative distance between the free end of the gripe and the bollard reduces, the angular velocity of the free end increases.

Because the gripe is of fixed length and the lifeboat was being lowered away, part of the load from the after falls momentarily transferred to the fouled gripe. The rate of descent of the lifeboat's after end decreased momentarily, but since the falls were still being paid out, the lifeboat's forward end became lower than its after end. The restraint on the after end, caused by the fouled gripe, also held the after end "in", closer to the ship side than the forward end.

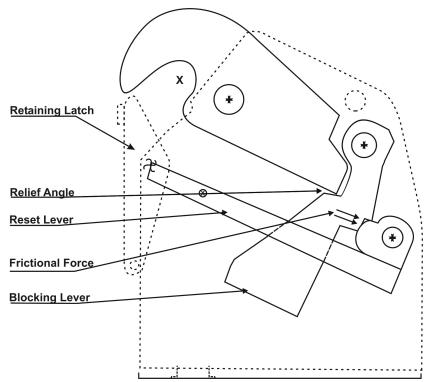
Figure 6. View of hook in load-bearing (reset) condition

The hook, the reset lever, and the blocking lever have been designed to rotate about pivots. To swing the blocking lever away and release the hook, the reset lever must first be moved out of the way. Since the reset lever moves in an arc, its contact surface with the blocking lever is also an arc. However, the corresponding contact surface of the blocking lever is planar, thus creating a line contact between these two surfaces (see Section 2.4.2). At its contact surface with the hook, the blocking lever has been given a relief angle of 18°. This angle also creates a line contact between them.

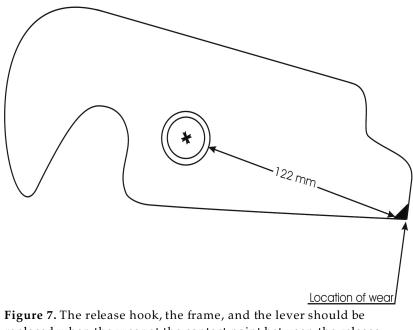
Hooks, designed to take a safe working load of 2.5 tons, have a minimum distance of 122.0 mm between the end of the loadtransmitting surfaces and the circumference of their pivots. Once this dimension has been reached. the manufacturer recommends that the hook, the blocking lever, and the frame be renewed. On the forward hook of the lifeboat, this dimension was found to be within specification at 122.6 mm. However, on the after hook it was found to be 121.8 mm on average (see Figure 7).

Figure 7. The release hook, the frame, and the lever should be replaced when the wear at the contact point between the release hook and the frame reaches 122 mm for a 2.5-ton hook.

Although this length on the after hook was found to be around 121.8 mm (0.2 mm below specification), the design had an adequate factor of safety, and there is no indication that this hook ever slipped past its blocking lever. However, the lifeboat and its hook assemblies were only about a year old, and the lifeboat itself had only been launched about four or five times. This use is not considered sufficient to have caused appreciable wear.

Minimal wear was found on this surface and the original radius was intact. The manufactured length from the end of the hook's load-transmitting surface to the circumference of its pivot was therefore 121.8 mm. Because the equipment was new and the wear minimal, this length is a deviation from the designed profile and indicates a manufacturing nonconformity.

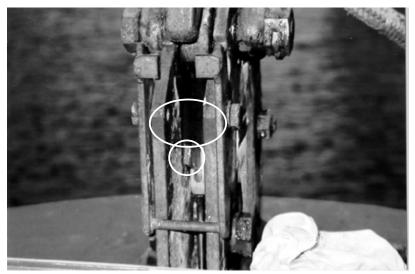
Photograph 20. Alignment marks between the cheek plates and the reset lever

When the hook is fully and properly reset, the red mark on the tip of the reset lever should line up with the corresponding red mark on the cheek plates of the hook assembly. This alignment provides visual feedback to the operator that the lever is in the correct position and confirms that the hook has been fully reset.

If the hook reset indicators are not aligned, the possibility of error exists, since the task now changes from one where a precise judgement is required (whether the red reference marks are aligned) to one where an imprecise judgement is required (whether the reference marks are "close enough"). Less precise specifications result in more subjective judgements and a greater risk of error.

When the reset lever is in its fully reset position, it is 12 mm lower than its maximum attainable position. Because the lever's reference marks were never in alignment in the first place, the drop of the reset lever goes unnoticed. Moreover, only the reset lever on the forward hook is readily visible. Static load testing of the hook assembly⁶ shows that, in this condition, the hook remains fully capable of bearing the applied load of the lifeboat and its contents.

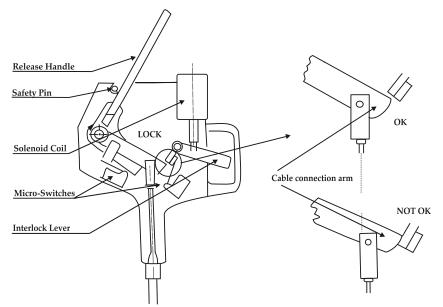
Figure 8. Internal schematic of central release control assembly

Once the reset levers have been moved into their locking position, they have no intrinsic force to hold them in place. By restricting the movement of the cable connection arms, the interlock lever holds the reset levers up. The interlock lever also holds the hooks in a condition where they can take the applied load and prevents the hooks from accidentally or inadvertently opening.
